Corrosion Protection of 376 ft Mechanically Shorted Pipe Casing in Mexico using Zerust's Zerion FVS, FAN-5, PGH-300, & PGH-400

Project Specifics

Casing Dia. 36", Carrier Dia. 30", Length 376-ft
Mechanically shorted

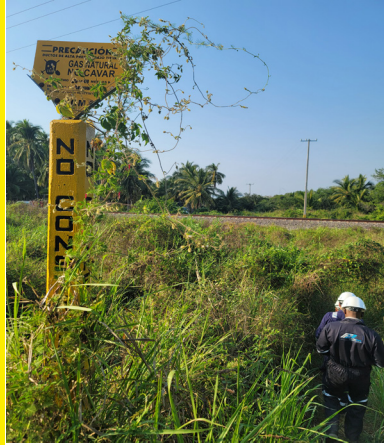
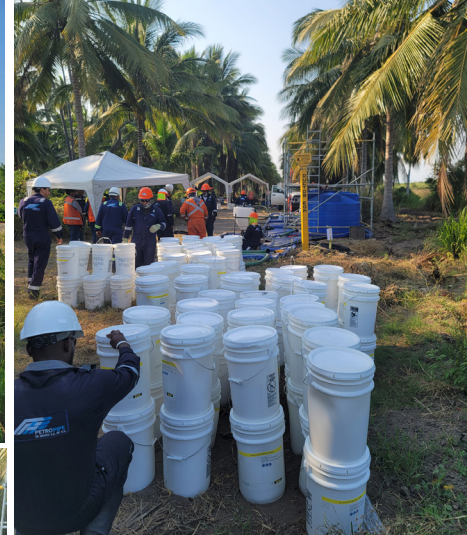
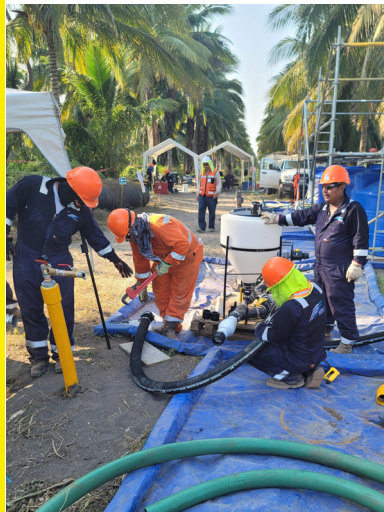
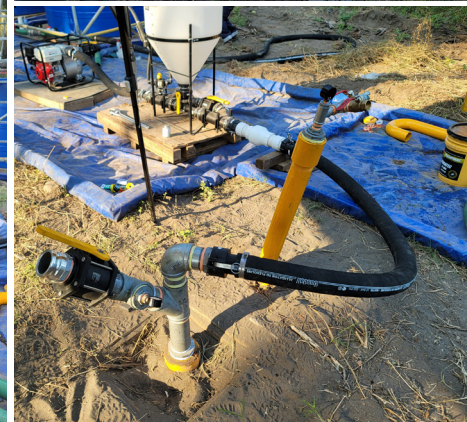
The contracting team had 4 (5000-L) polyurethane tanks that were used for premixing the Zerion FVS and FAN-5 corrosion inhibitors with water. The entirety of the corrosion inhibitor solution to be injected was done so in batches. Tanks were first connected in series, with 3" T-valves, independently of each other through a one-way hose to the eductor system.

After the circulation of corrosion inhibitors, the introduction of the Zerion PGH-300 and Zerion PGH-400 corrosion inhibitor gels was done through the eductor system and the solution batches were injected using the bottom vent.

For proper distribution, a higher concentration was premixed in the first three (3) injected batches, with the last batch being just potable water. During the injection of the corrosion inhibitor solutions, the contractors simultaneously mixed the Zerion PGH-300 and PGH-400 corrosion inhibitor gels at a constant flow.
