Corrosion Protection for an Out-of-Service Storage Tank on Sand Foundation using Zerust's Zerion® FAN-6 Corrosion Inhibitor

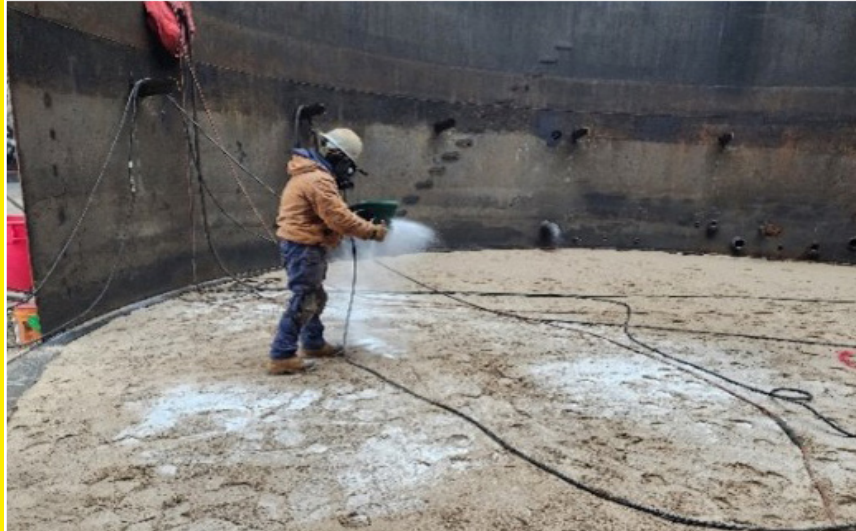
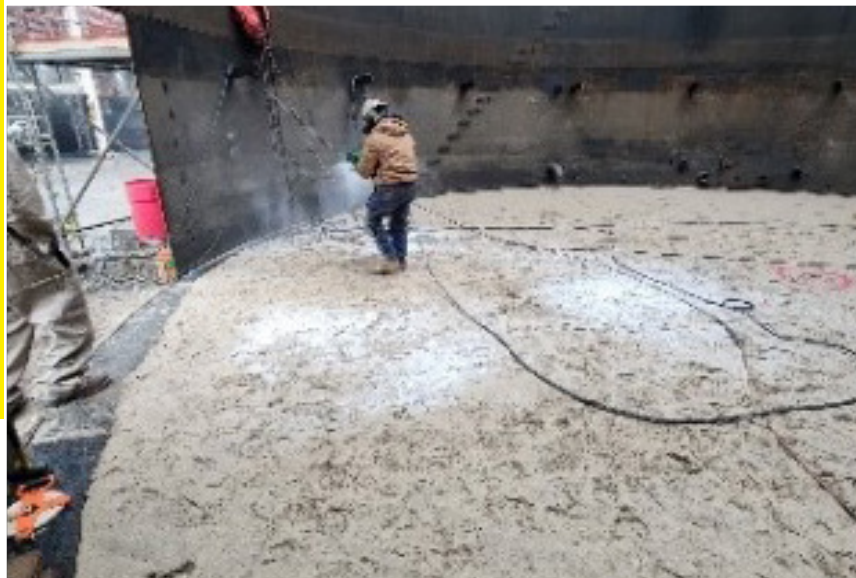
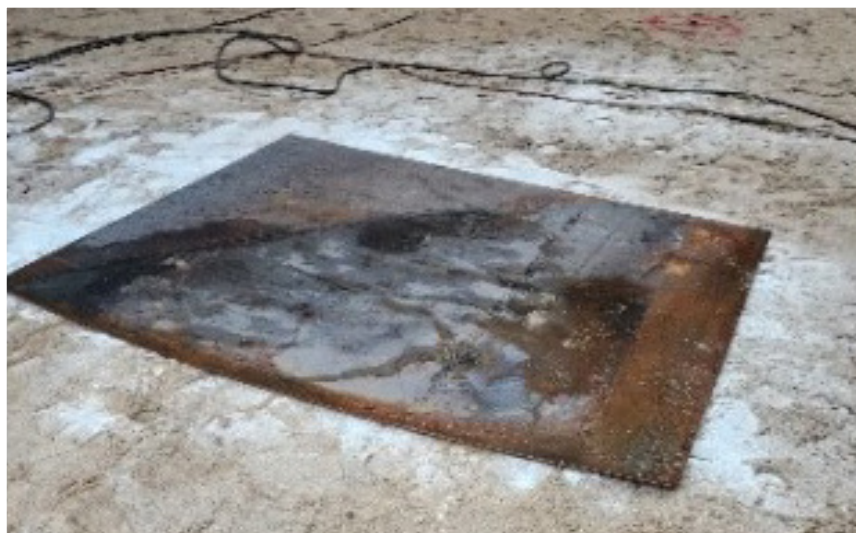
The original tank floor was removed for replacement, exposing the sand base, and the tank ceiling was absent. Installation used a top-dressing technique, spreading Zerion FAN-6 powder at an approximate rate of 400 grams per square meter, covering around 30 square feet before rain halted work. A metal sheet protected the treated area before departure.

Zerust left before completing the corrosion inhibitor application, which the contracted team would finish when the weather improved. After spreading FAN-6 on the sand base, the next step was installing a new tank floor, with Zerust recommending sealing the chime area using polyurethane construction adhesive.
