## Corrosion Protection for a Single Bottom Storage Tank on Concrete Foundation using Zerust's Zerion® FVS Corrosion Inhibitor Sleeves

The client needed routine maintenance on their chime seal, leading to its removal and replacement.

The chime seal from 250° to 270° was entirely replaced. Fresh concrete sealing (epoxy paint) was applied as a base, followed by the installation of brand-new Zerion FVS-S15 corrosion inhibitor sleeves, Viscotaq EZ Wrap, and a double layer of Sherwin Williams Uniflex 44-300. The replacement process proceeded without any complications.

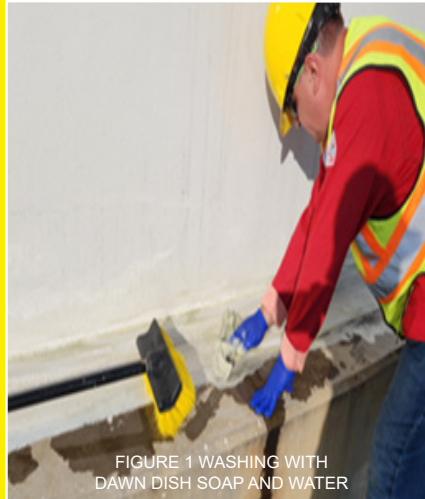
FIGURE 1 WASHING WITH DAWN DISH SOAP AND WATER

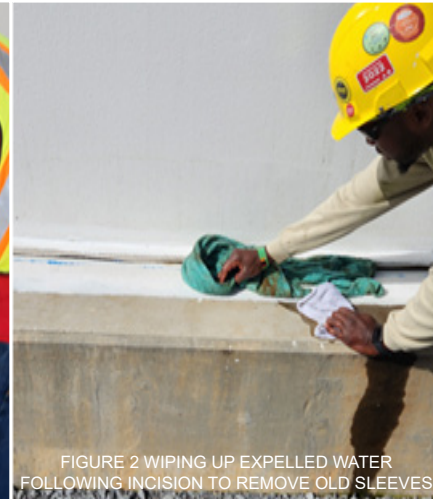
FIGURE 2 WIPING UP EXPELLED WATER FOLLOWING INCISION TO REMOVE OLD SLEEVES

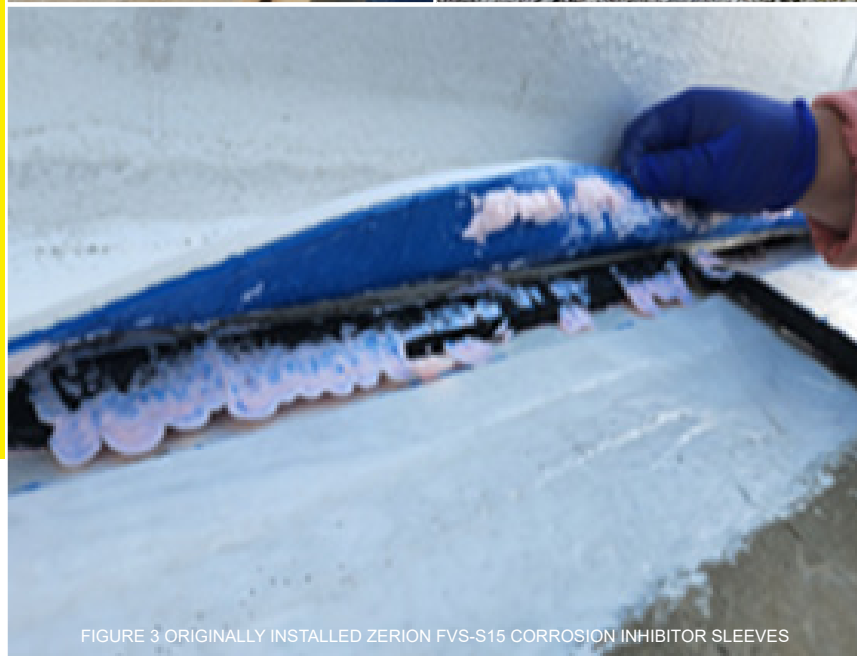
FIGURE 3 ORIGINALLY INSTALLED ZERION FVS-S15 CORROSION INHIBITOR SLEEVES

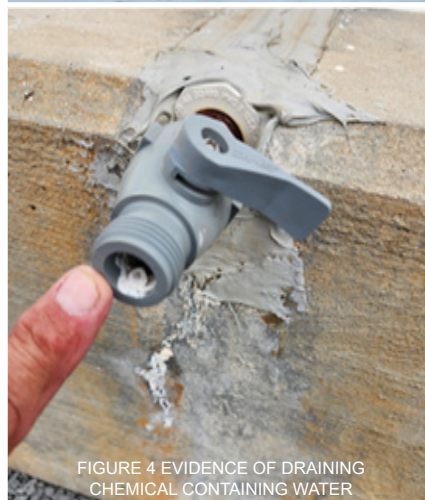
FIGURE 4 EVIDENCE OF DRAINING CHEMICAL CONTAINING WATER

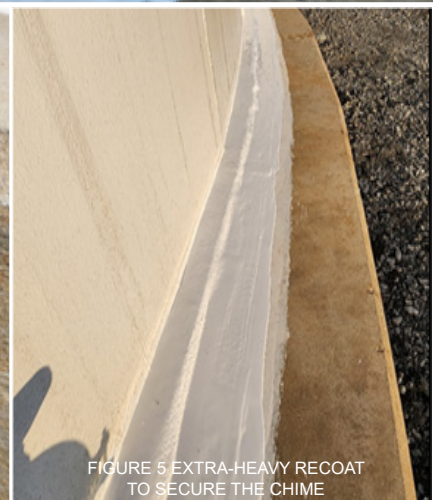
FIGURE 5 EXTRA-HEAVY RECOAT TO SECURE THE CHIME

The chime repair, which lacked epoxy sealer, unfolded as planned. The double coating of the entire chime area created a robust seal with lasting durability. To maintain a pristine appearance and prevent green algae buildup, we suggest periodic light washing with water and dish soap. It's important to avoid applying any overcoat on the silicone seal and keep the ports closed to retain the anti-corrosive properties of Zerust chemicals.
