## Corrosion Protection for a Single Bottom Storage Tank on Sand Foundation using Zerust's Zerion® FVS via Internal Flood

Diameter: 143-ft

**Vessel Construction:** Single-Bottom, 12" Sand Foundation, no slope, liner, concrete ring wall

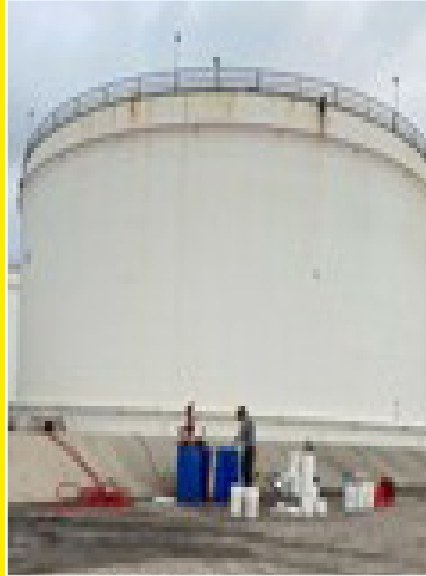
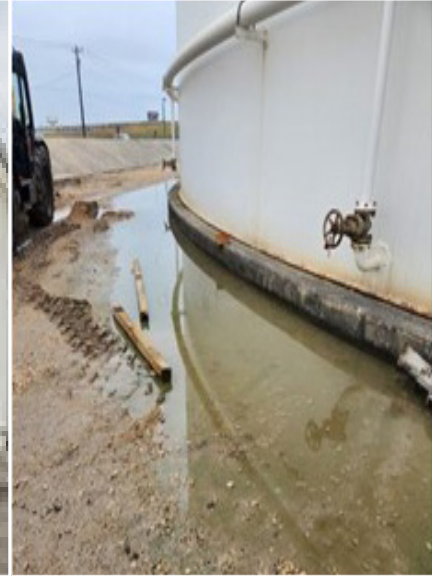
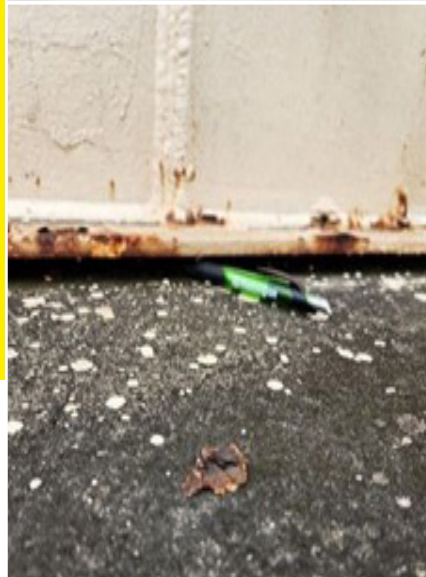
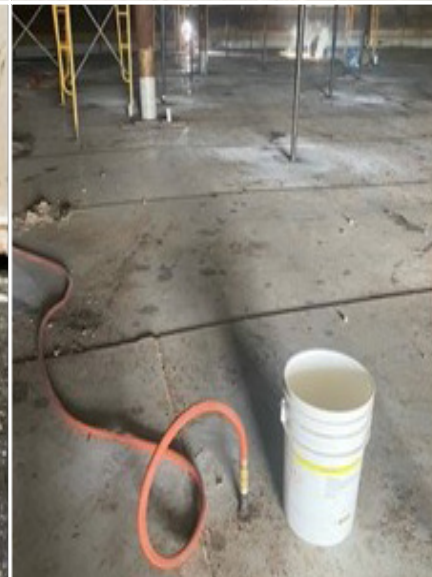
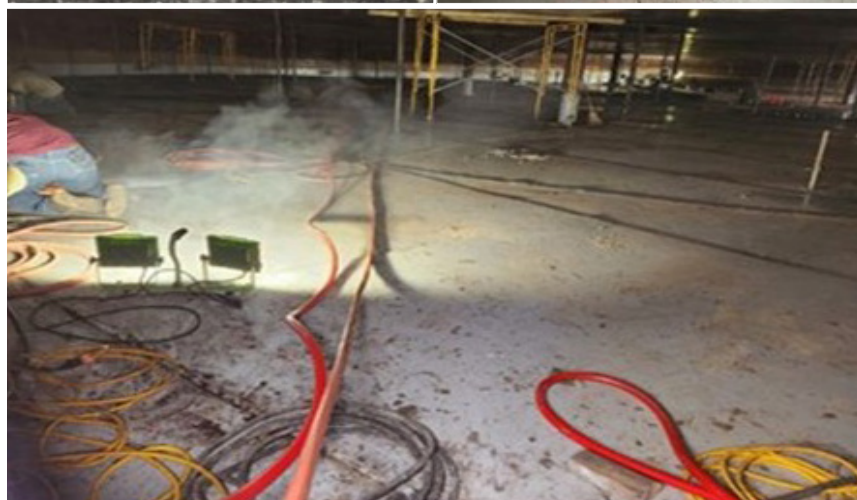
We expertly combined pails of FVS with water within a 55-gallon drum using a submersible pump. The entire solution was seamlessly injected through six-floor ports without any complications. In the near future, a Buckeye contractor will take care of installing the chime seals.

Furthermore, we installed two ER probes in the designated leak detection ports, leaving the remaining two ER probes in the capable hands of the client. This collaborative effort ensures a comprehensive approach to our project.

The project achieved success. To maintain solution integrity, prompt chime sealant installation is advised to prevent unintended leakage. For ongoing corrosion monitoring, send monthly probe readings to Zerust Oil & Gas, ensuring continued effectiveness in corrosion prevention.
