CASE STUDY

Pipe Layup Project Corrosion Protection of Pipe Segments using Zerust's ActivPak® (LS)-35

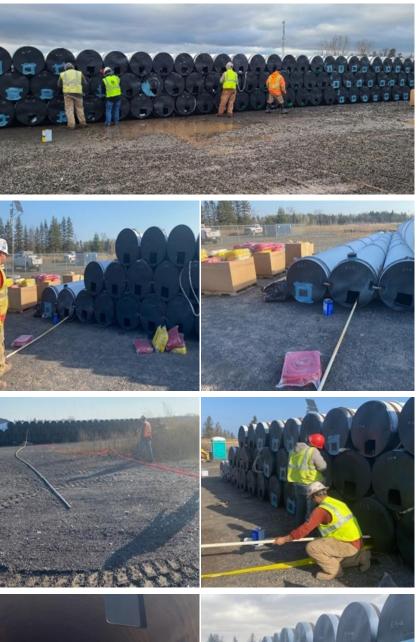
The custom corrosion solution provided included the installation of custom ActivPak® (LS)-35 corrosion inhibitor lead assemblies into each pipe segment.

All 622 pipes had custom ActivPak (LS)-35 corrosion inhibitor lead assemblies installed.
